# MDS89745RA/RAH Assembly Guide

Model number: MDS89745RA/RAH

## Guide to avoid or correct common assembly error for the MDS89745RA/RAH bath bench

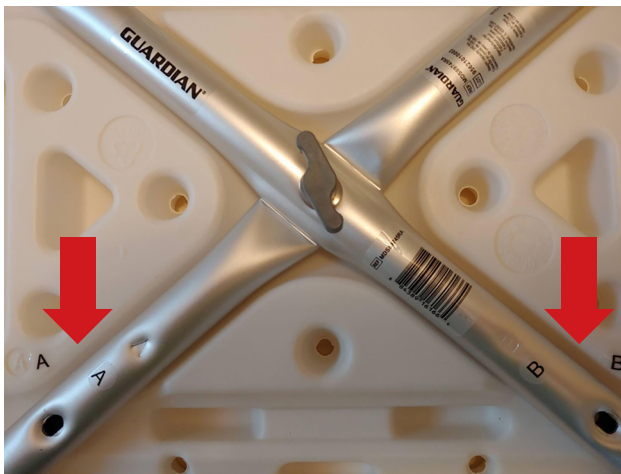
When installing the aluminum main frames, the imprinted A and B must be attached next to the corresponding A and B on the underside of the seat.

The initial steps shown in the assembly instructions must be followed exactly or the assembly will not be able to be completed.

If this is not done correctly the padded armrests will not be able to be installed.

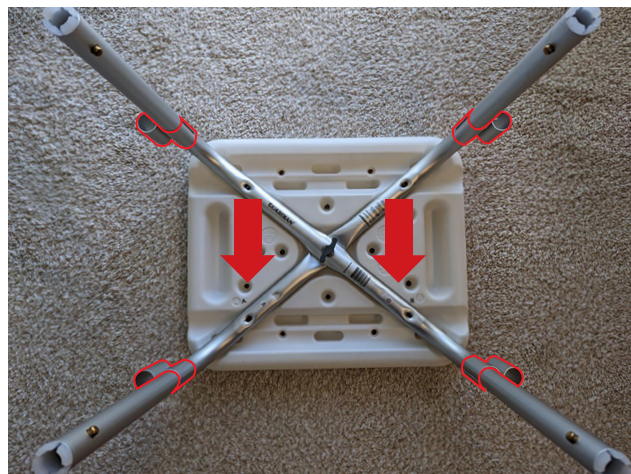
With the A/B lined up (shown by arrows) the arm rest holsters will be on the outside of the seat and legs.

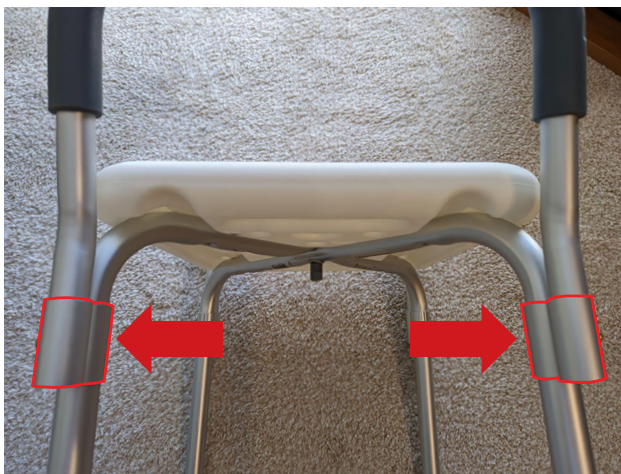
Armrests installed correctly.

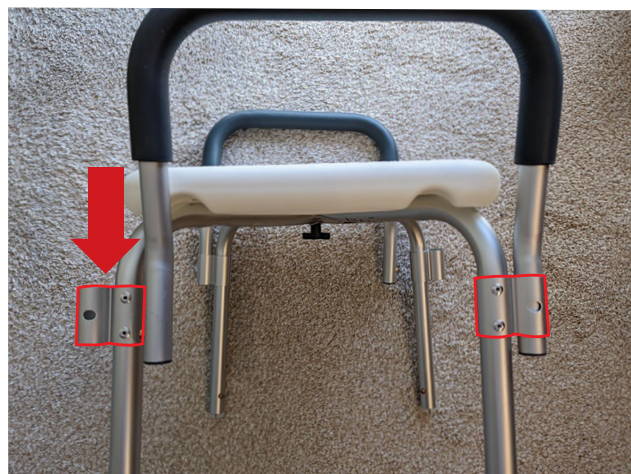
Installed incorrectly.
